Situation Photo Log

Monday, July 30, 2012

Weather / River Conditions for Friday July 27, 2012

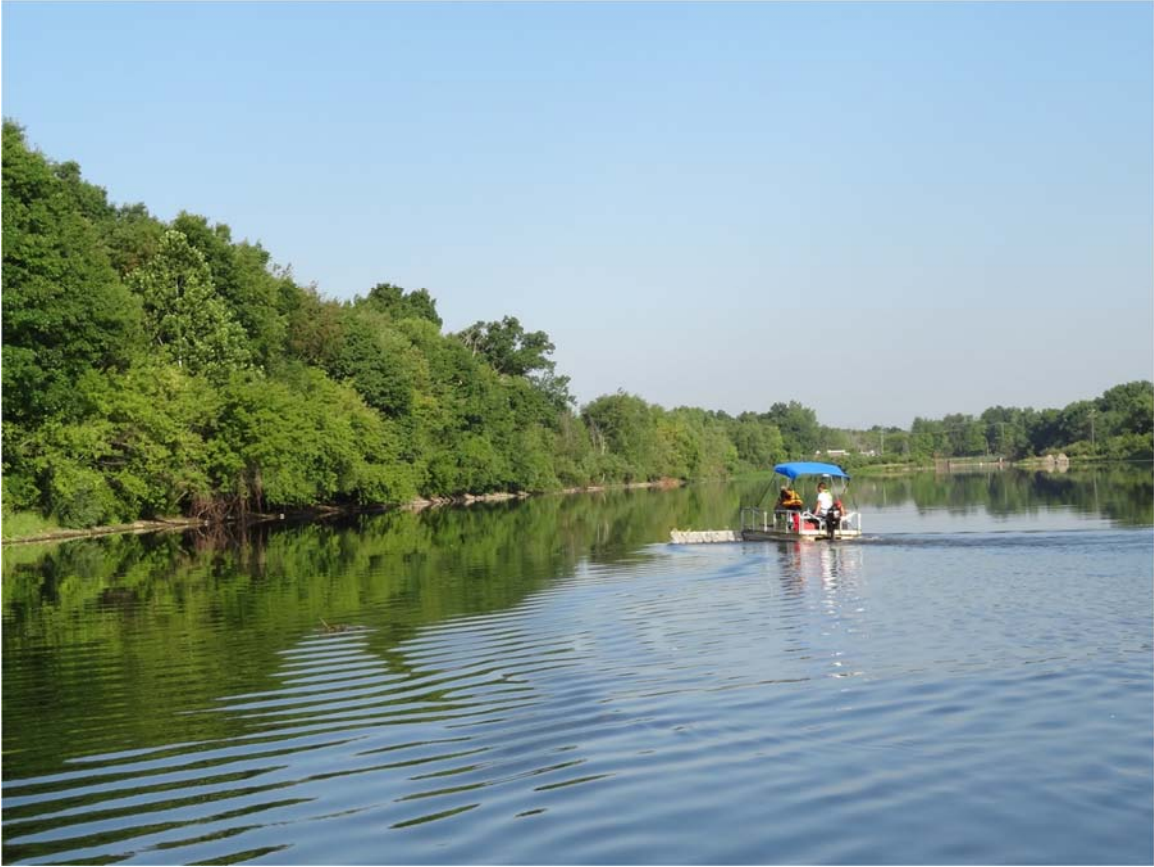
1. MP5.25 LDB observed the sheen sweep boat operating.

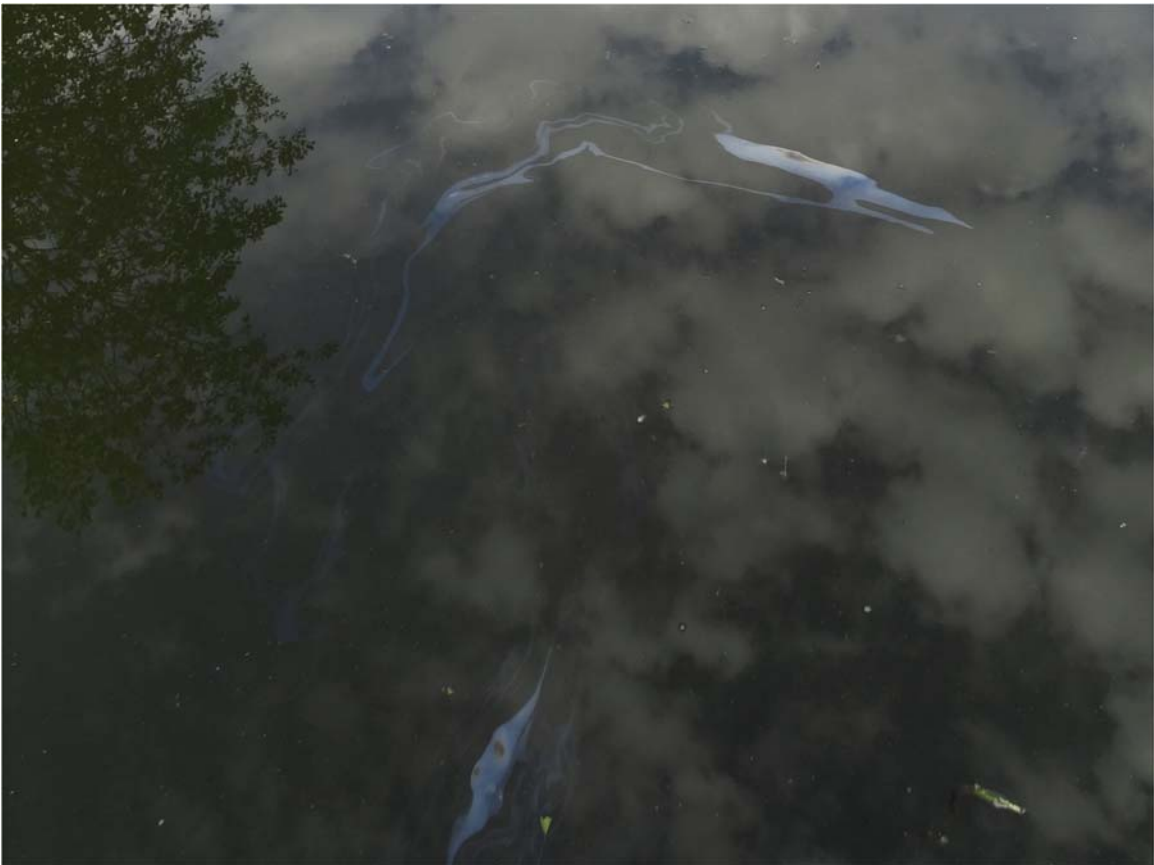
2. MP5.25 LDB sheen observed.

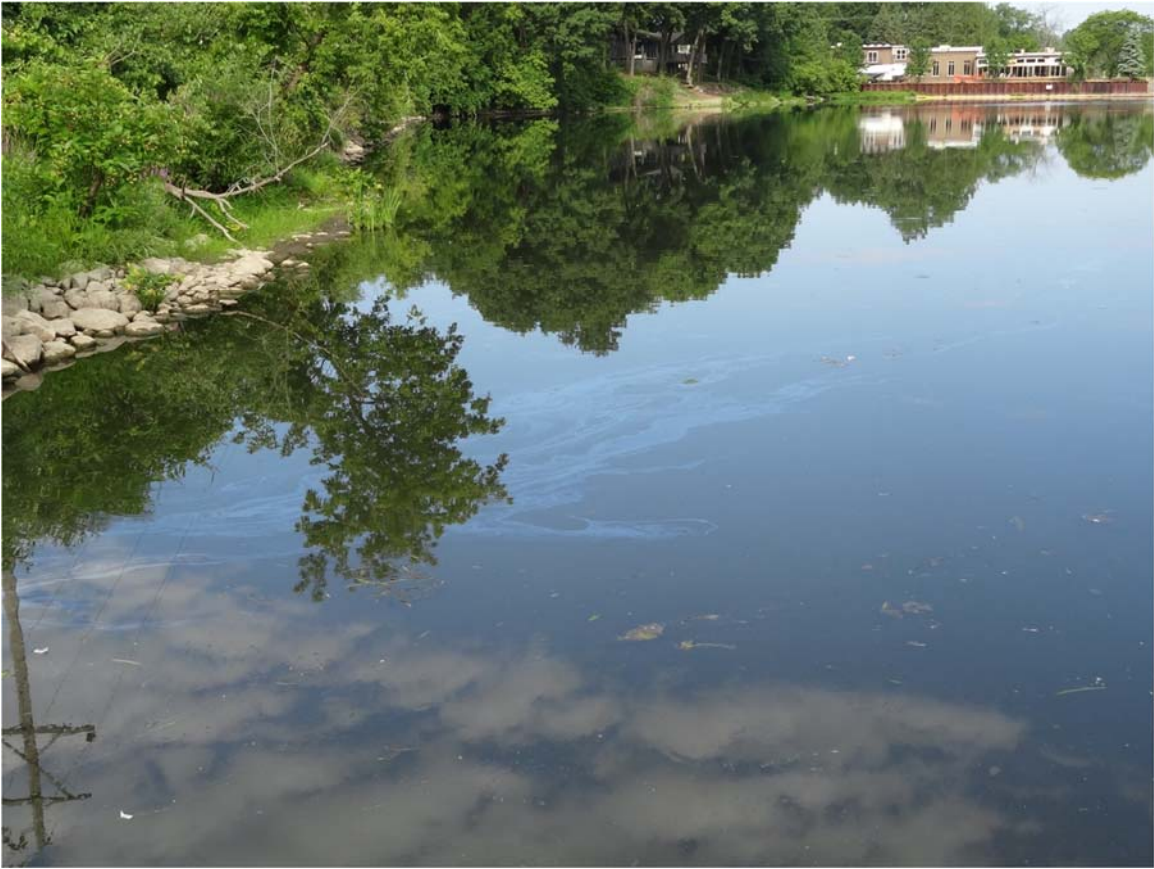
3. MP5.63 LDB sheen observed.

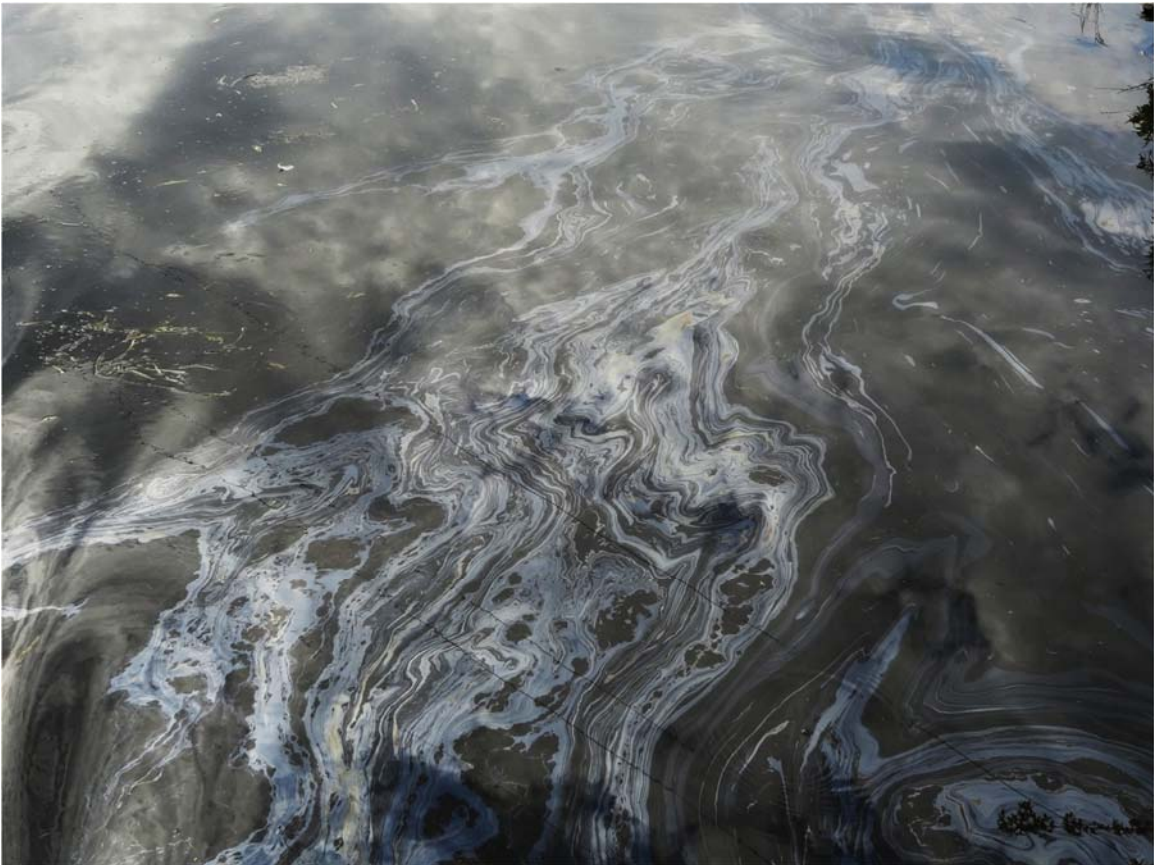
4. MP5.63 LDB sheen observed.

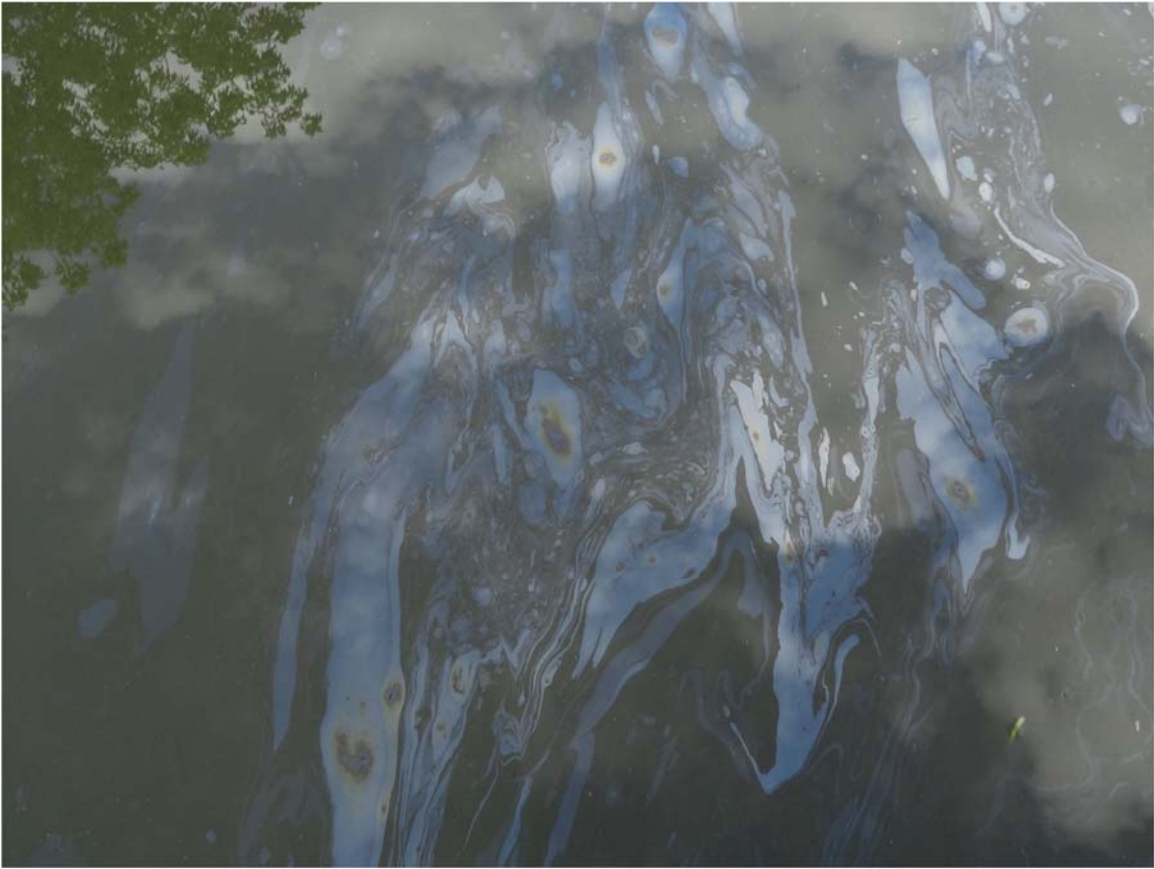
5. MP5.63 LDB sheen observed.

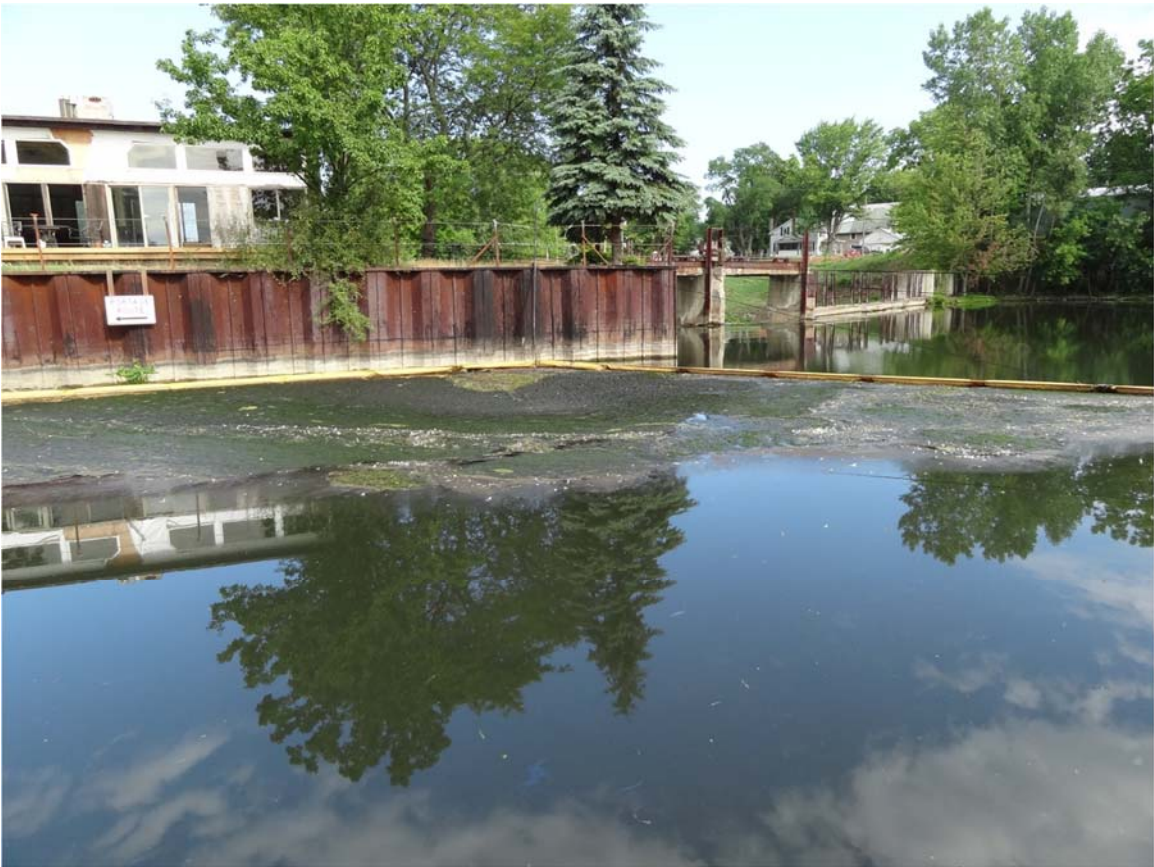
6. Ceresco Dam debris buildup along the control point.

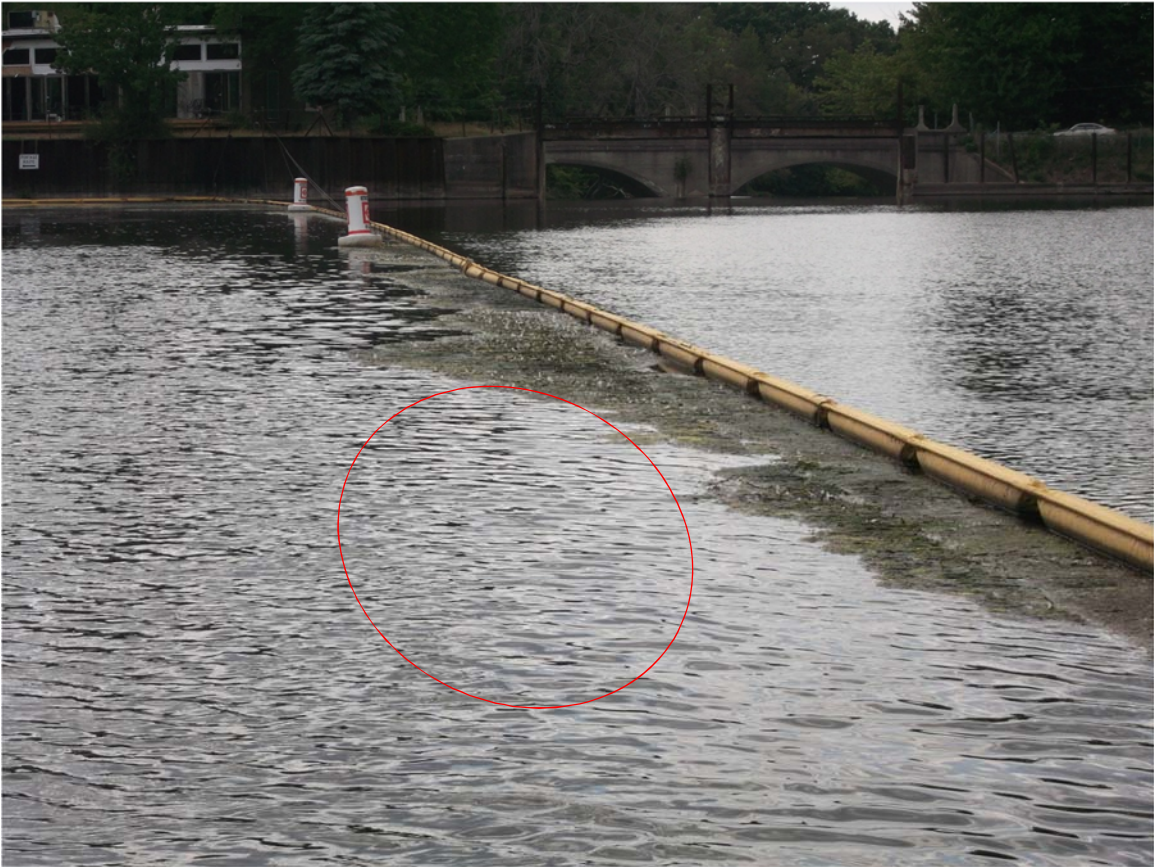
7. Ceresco Dam control point sheen observed.

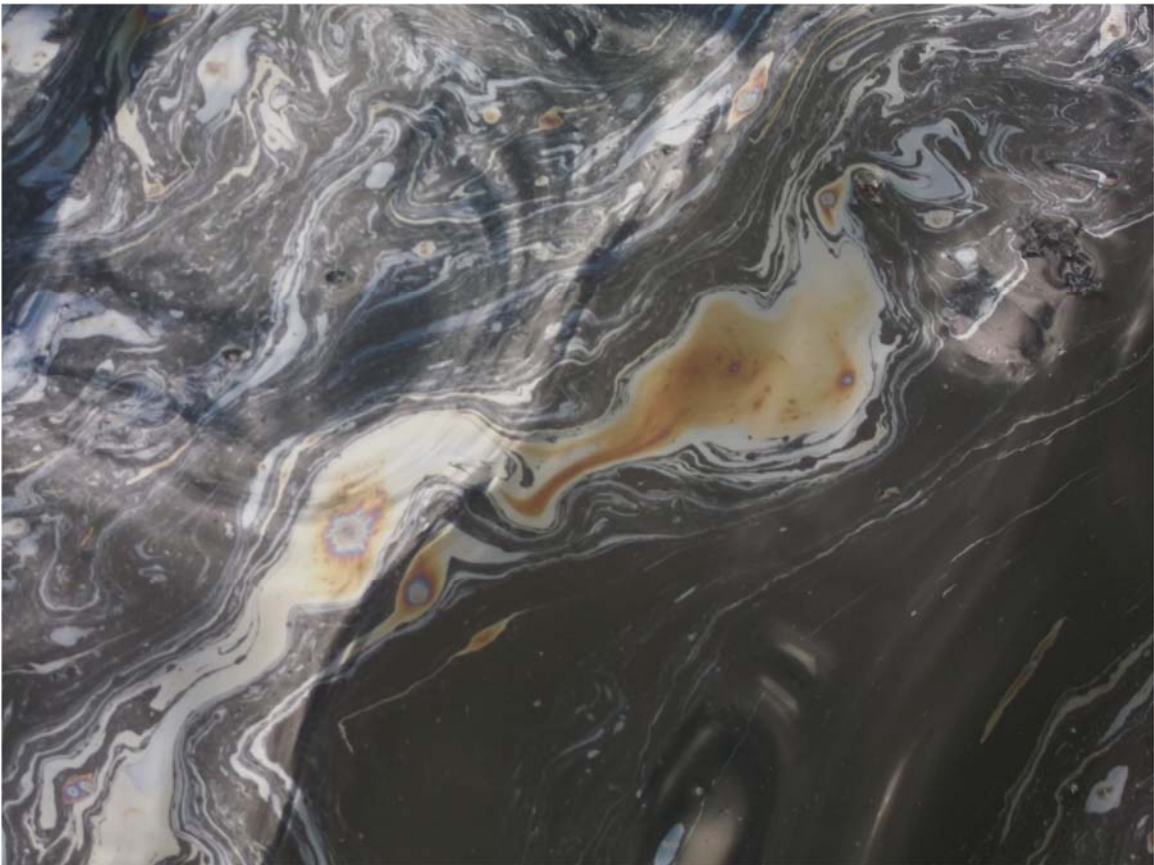
8. Ceresco Dam control point sheen observed.

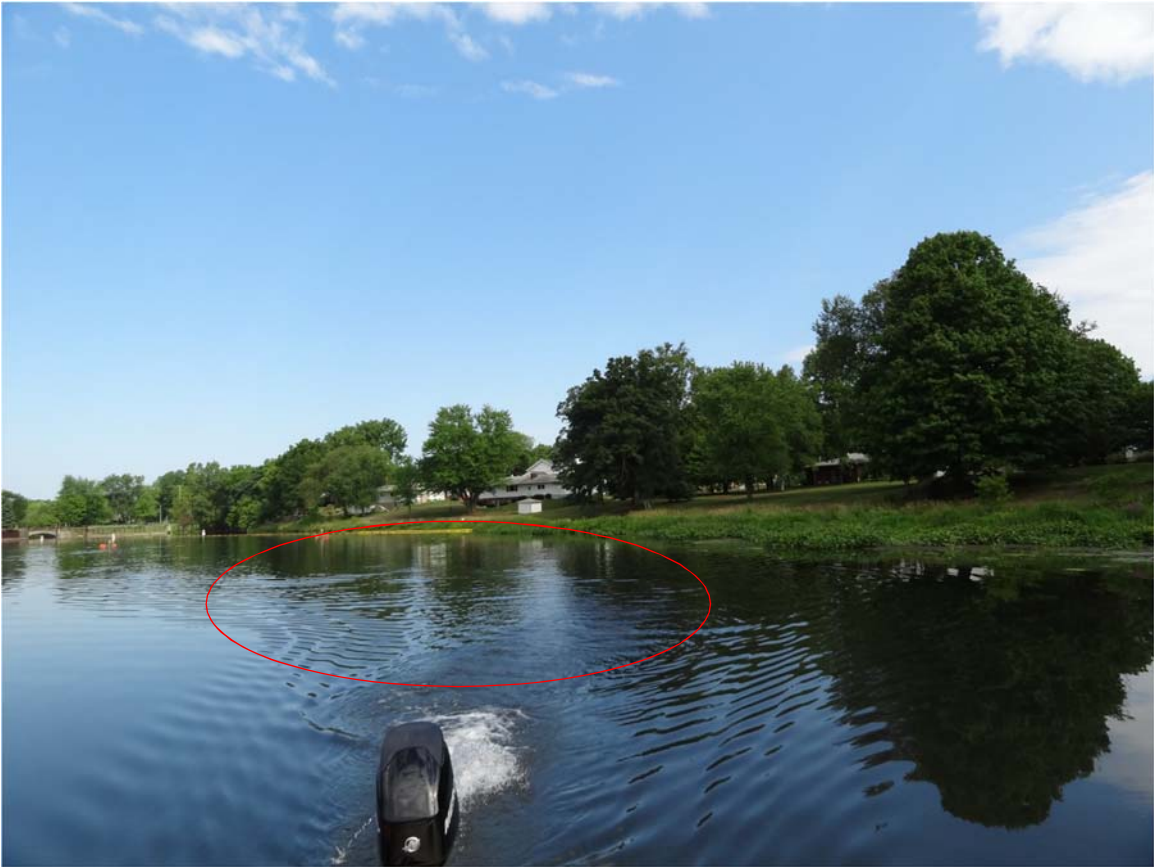
9. Large area of sheen observed above the Ceresco Control Point.

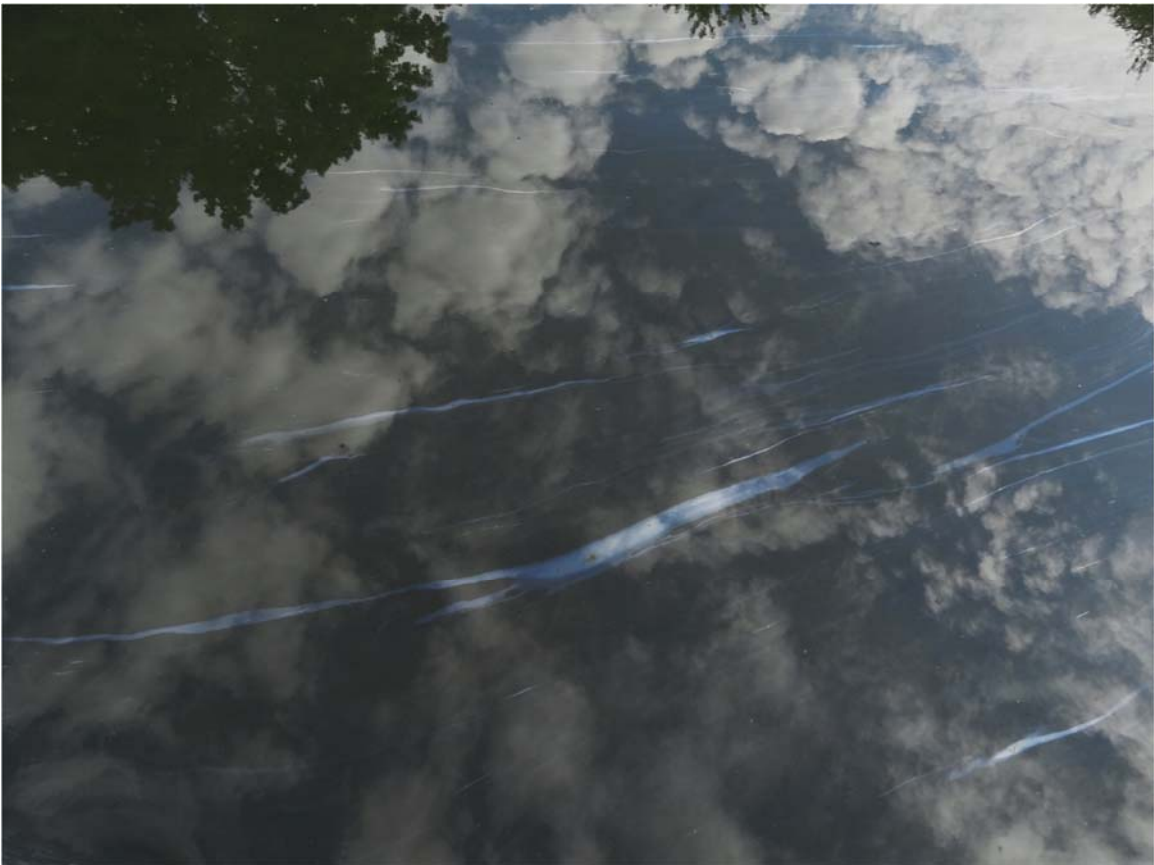
10. Large area of sheen observed above the Ceresco Control Point.

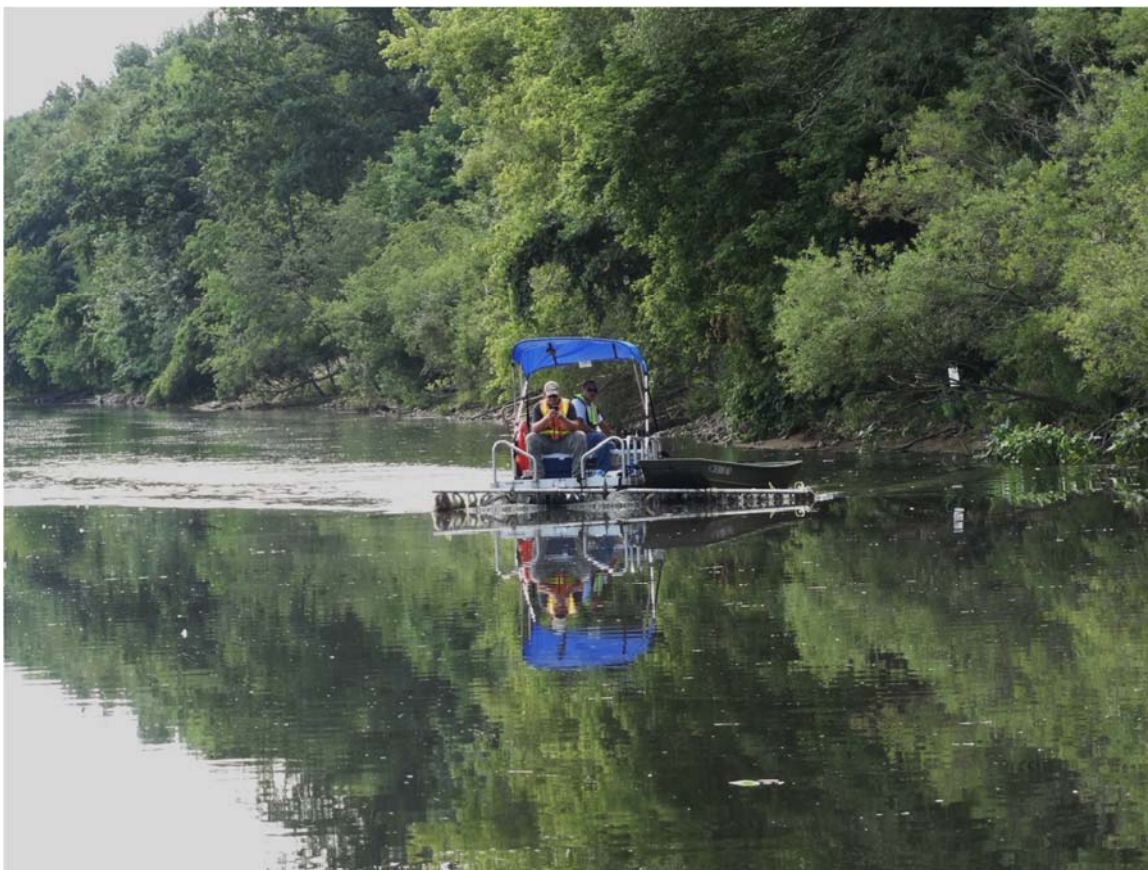
11. Ceresco Dam boom maintenance crew observed mobilizing to perform boom maintenance.

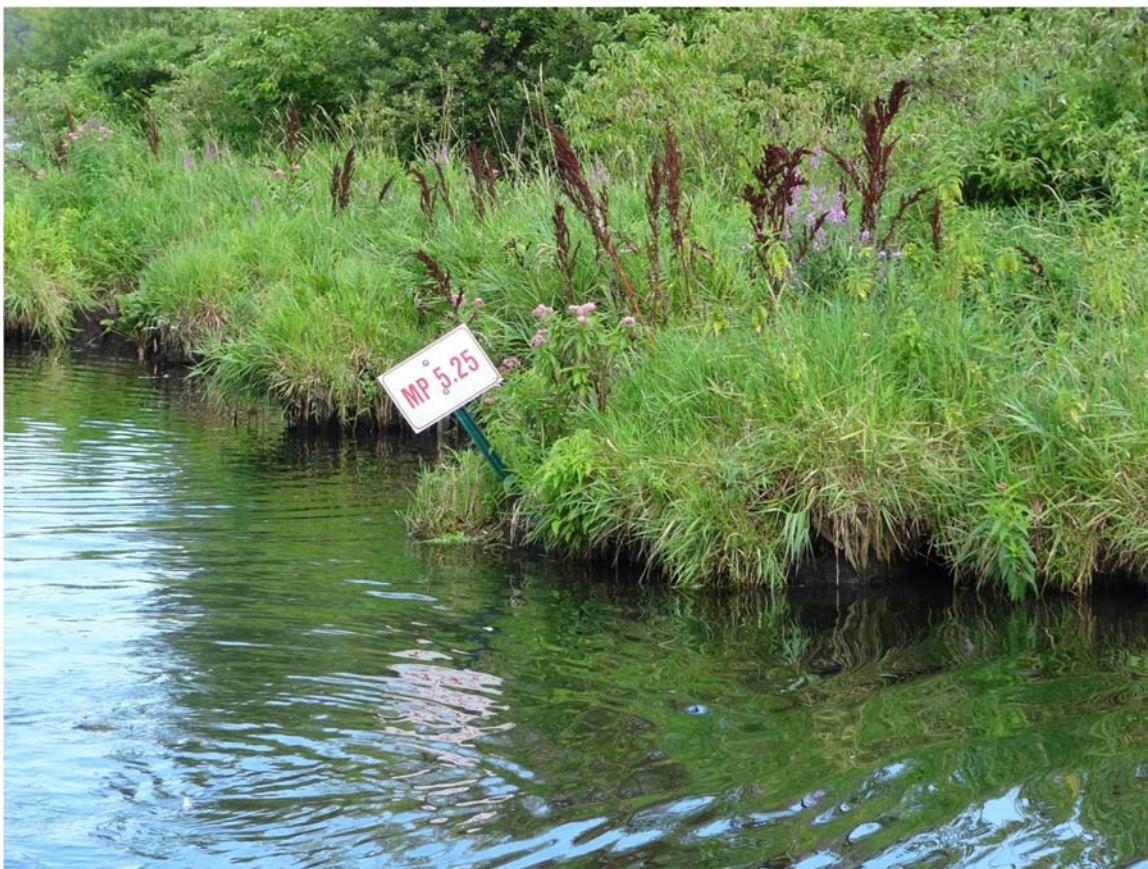
12. MP5.25 RDB sheen observed.

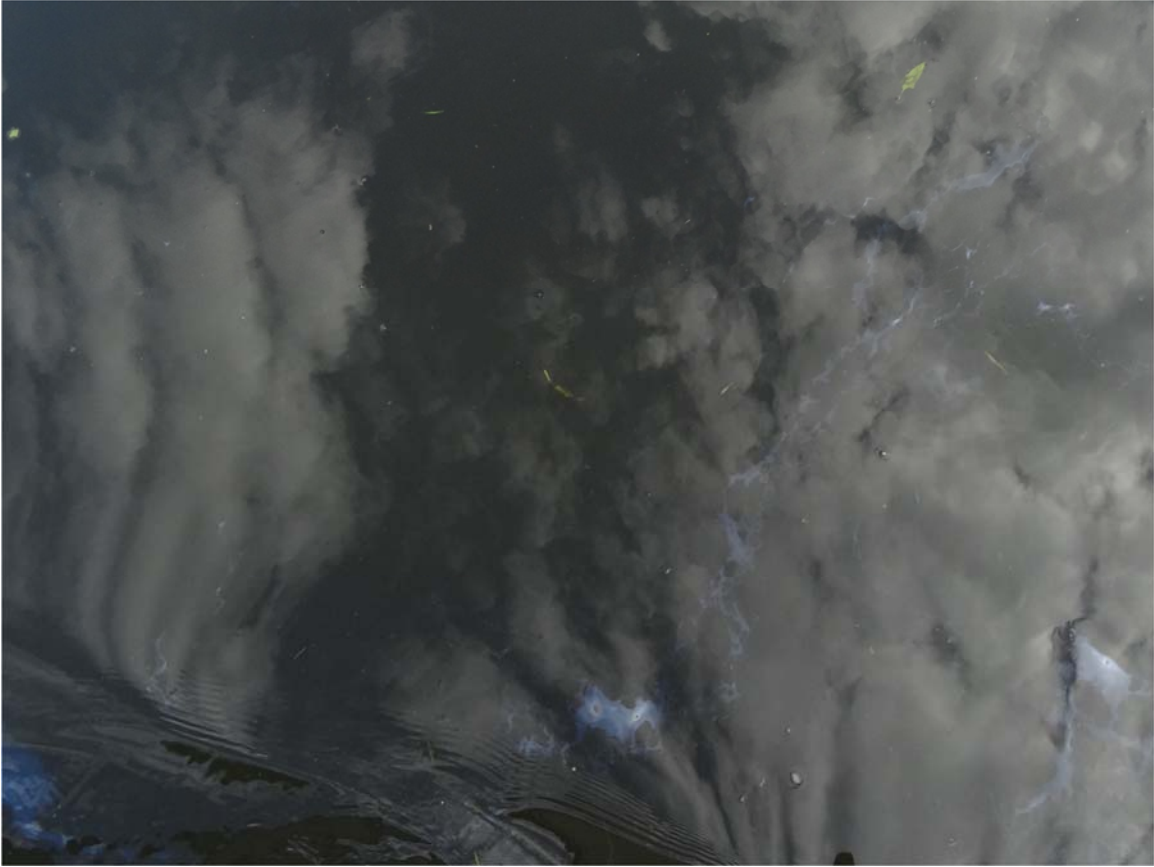
13. MP5.25 RDB sheen observed.

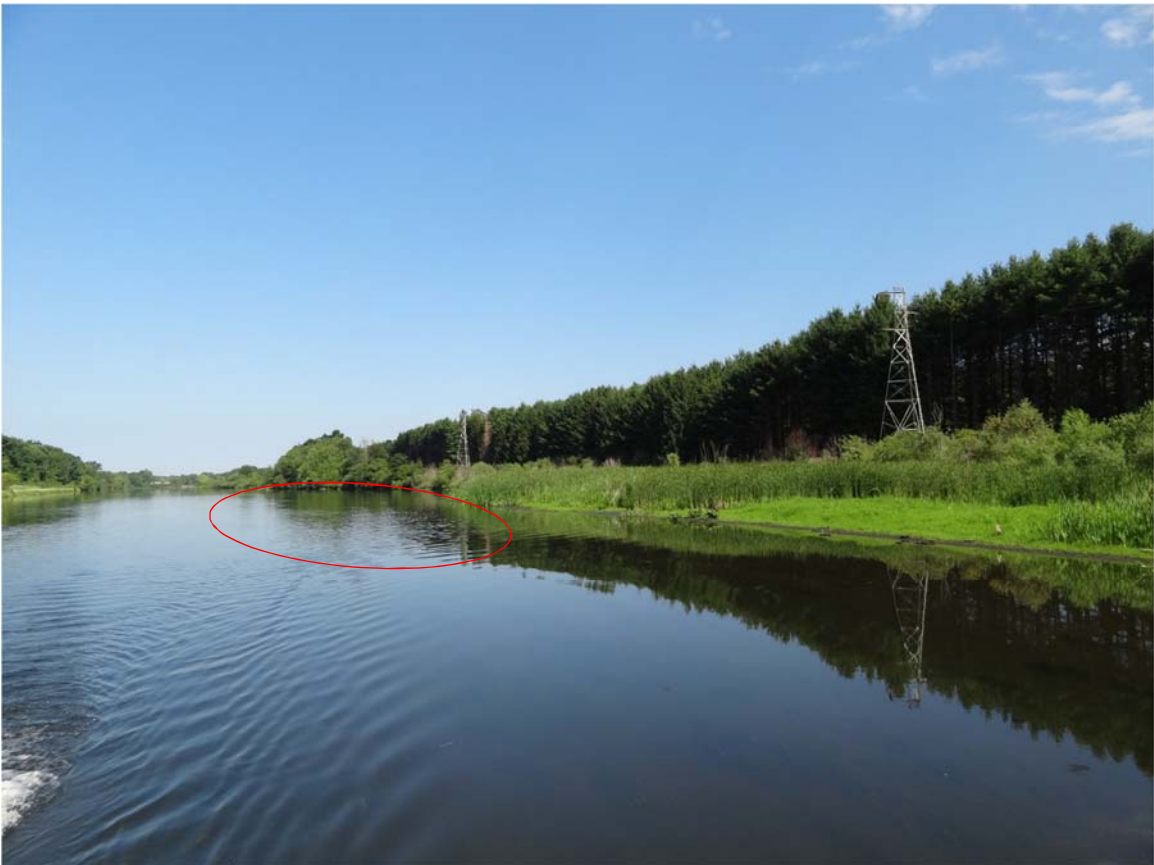
14. MP5.0 – MP5.25 RDB sheen observed.

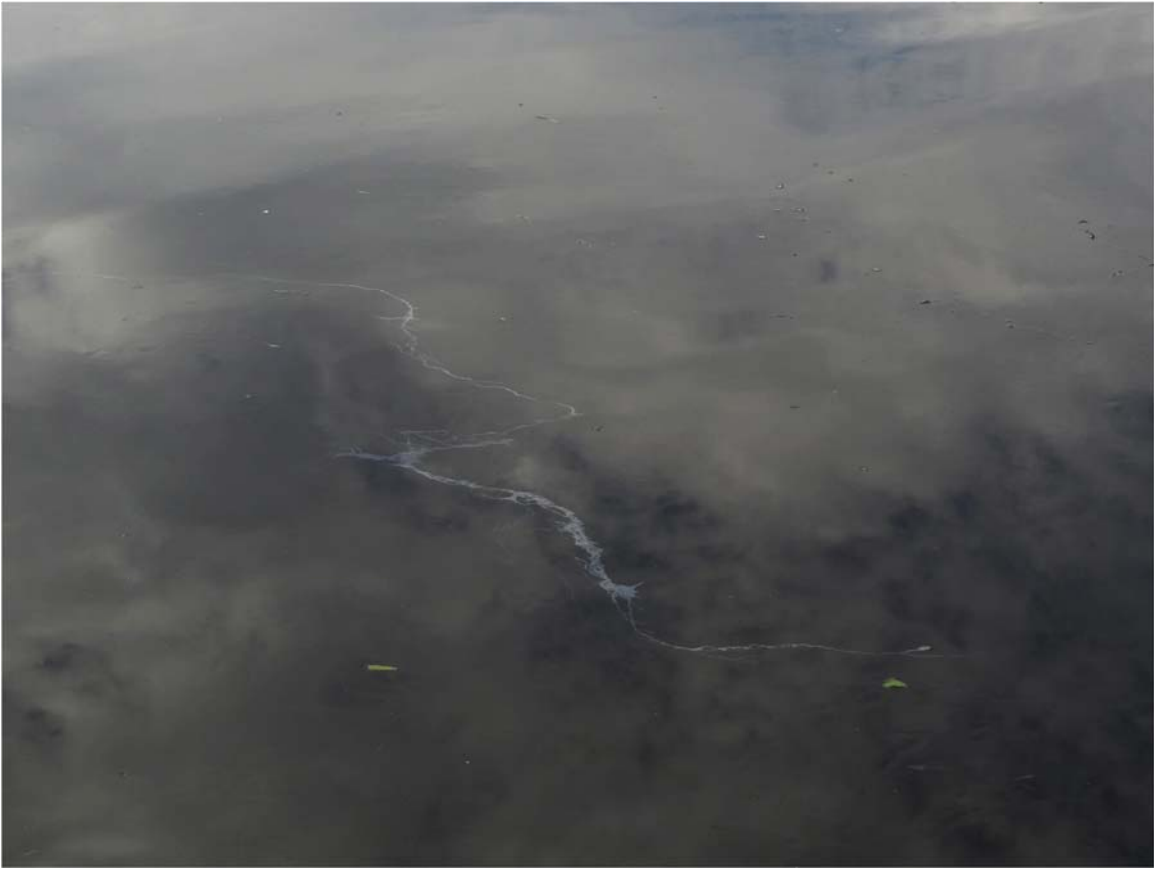
15. MP5.0 – MP5.25 RDB sheen observed.

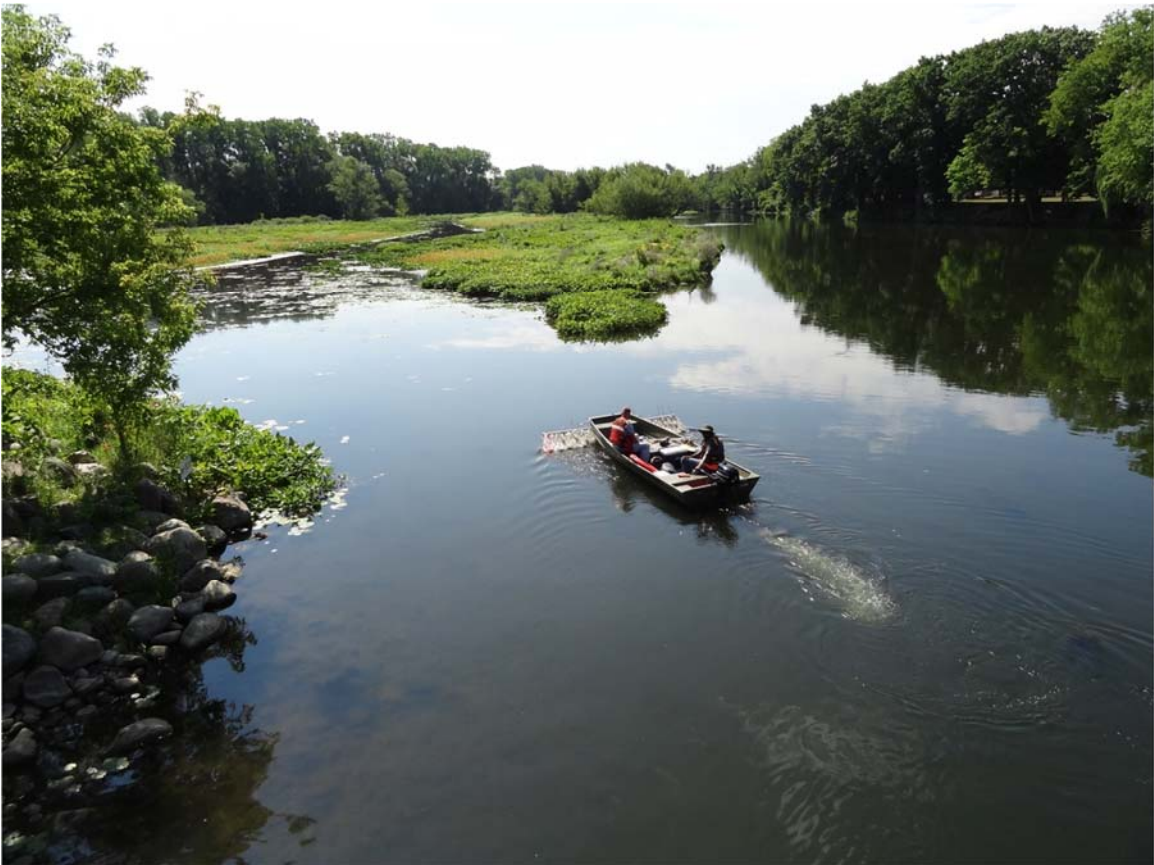
16. MP15.5 South Mill Pond observed sheen sweep boat operating.

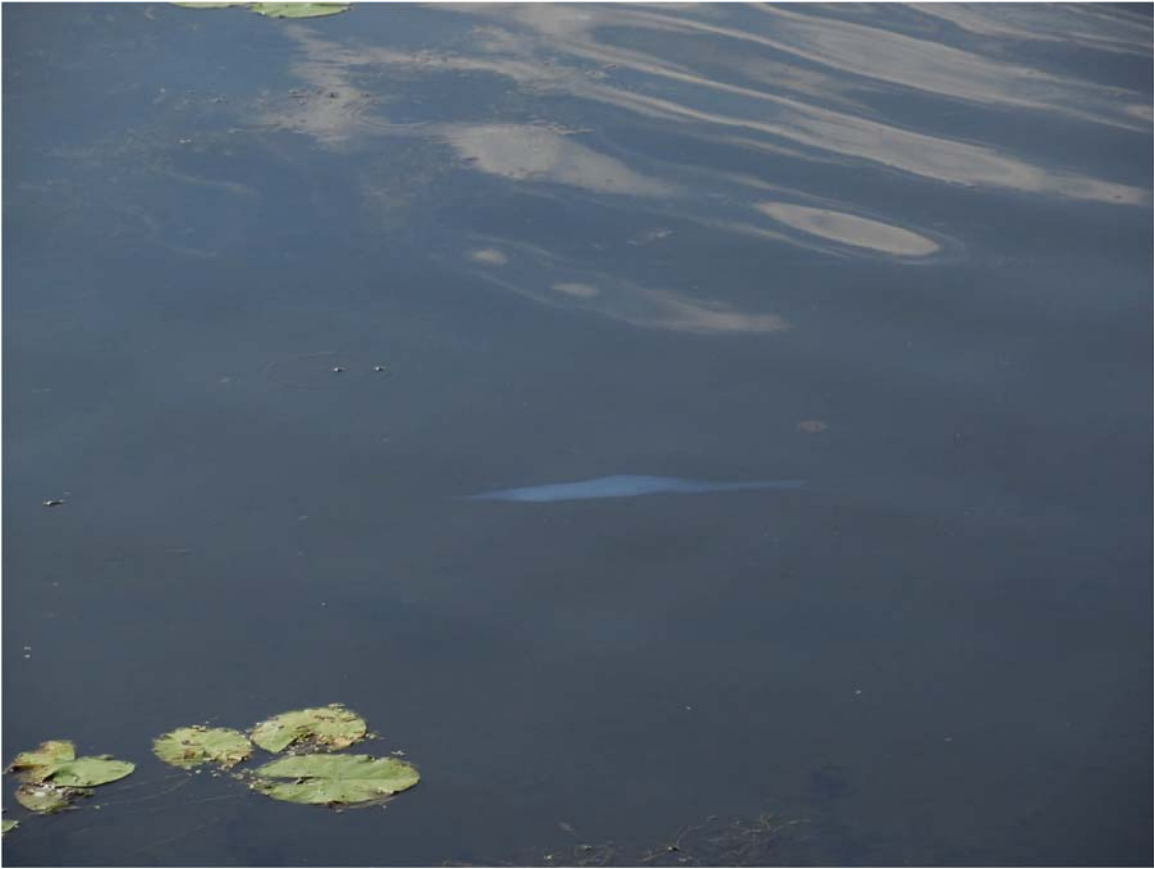
17. MP15.5 South Mill Pond observed sheen within Mill Pond.

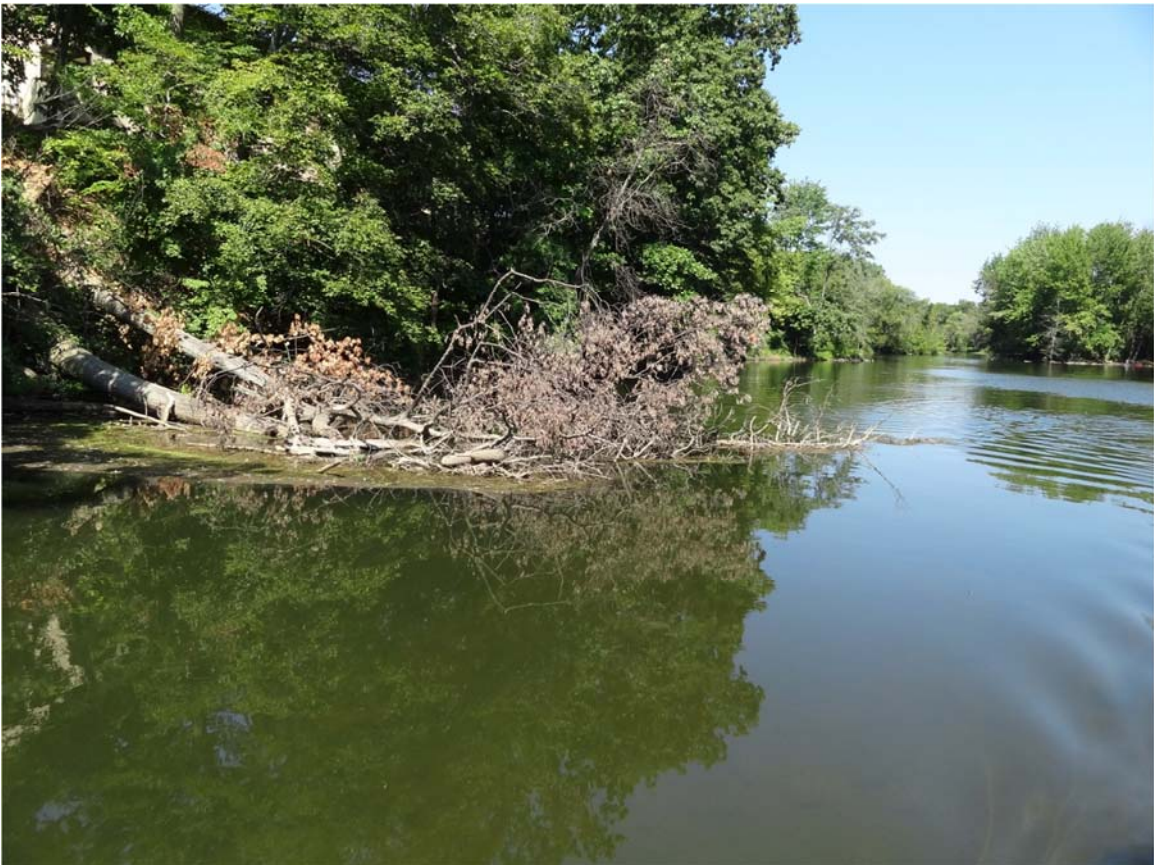
18. MP14.5 LDB observed sheen.

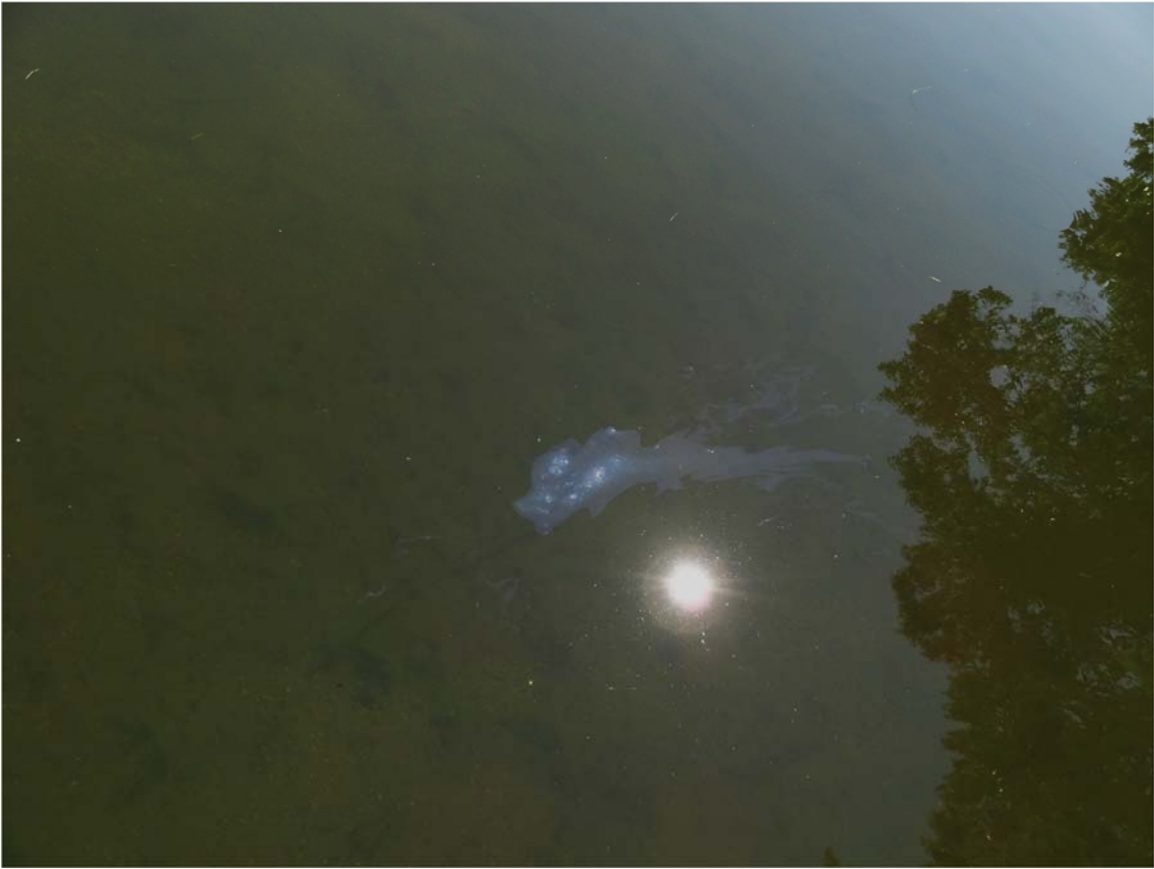
19. MP14.5 LDB observed sheen.

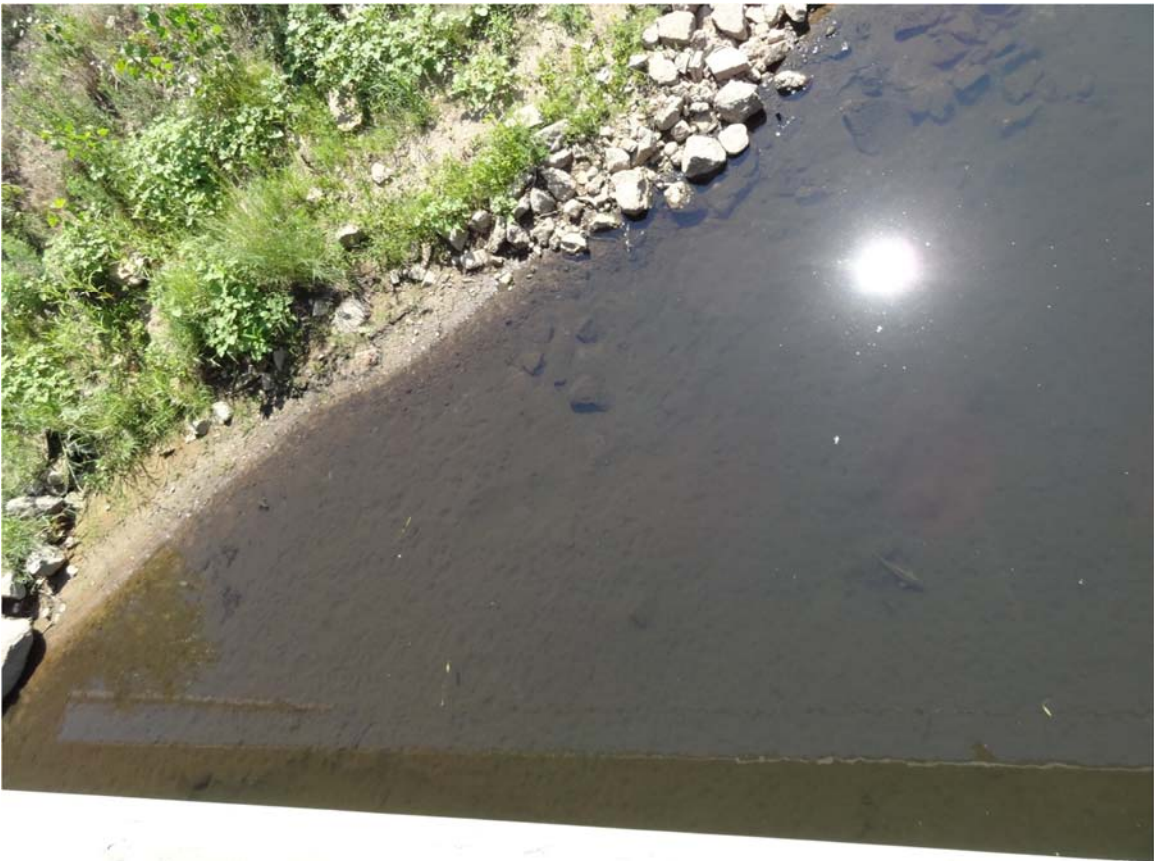
20. MP21.5 RDB Custer Bridge, no sheen observed.

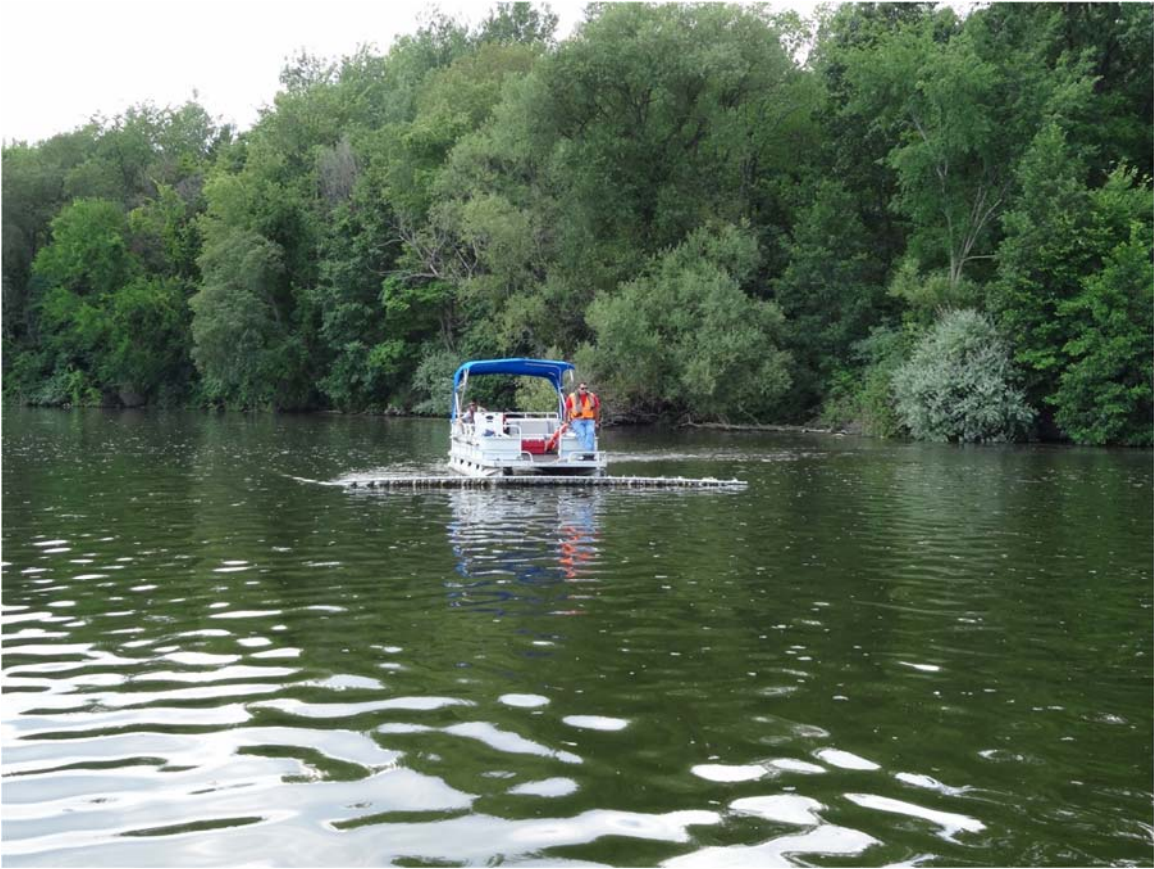
21. Morrow Lake north cove observed the sheen sweep boat operating.

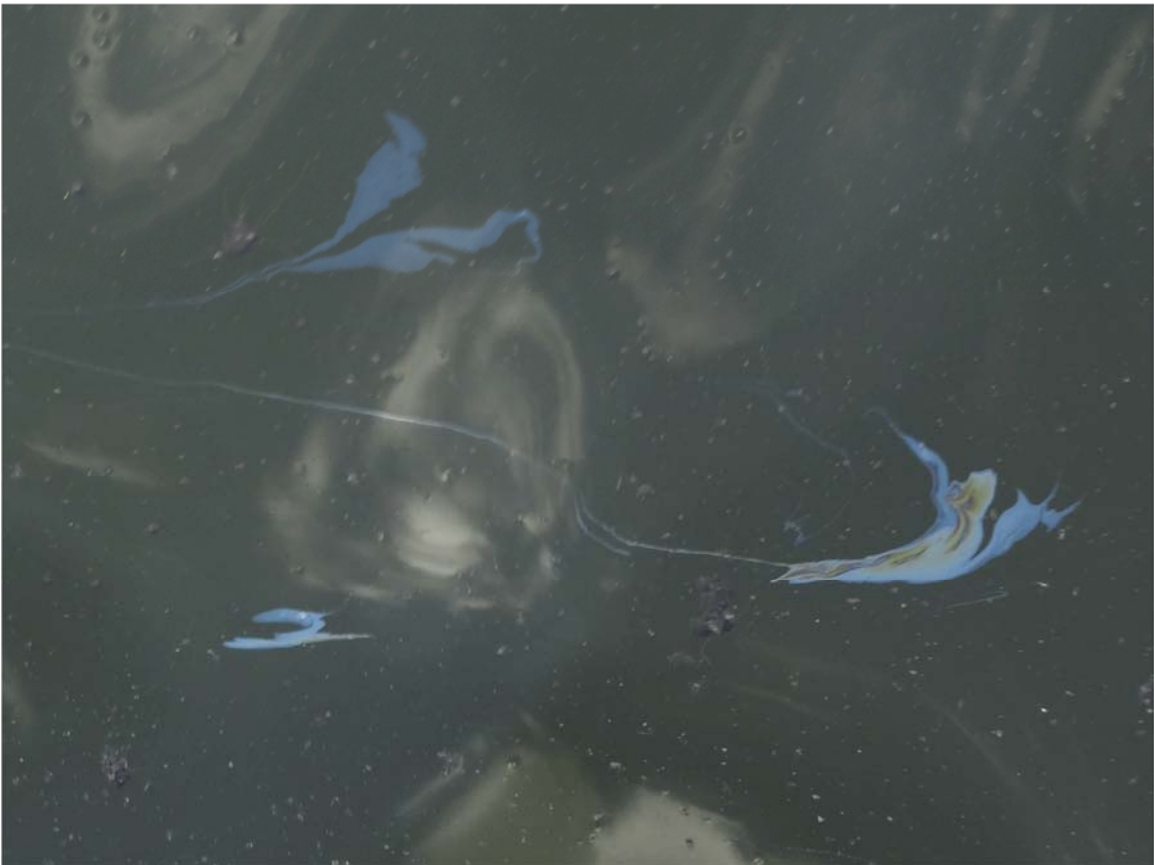
22. Morrow Lake north cove observed sheen.

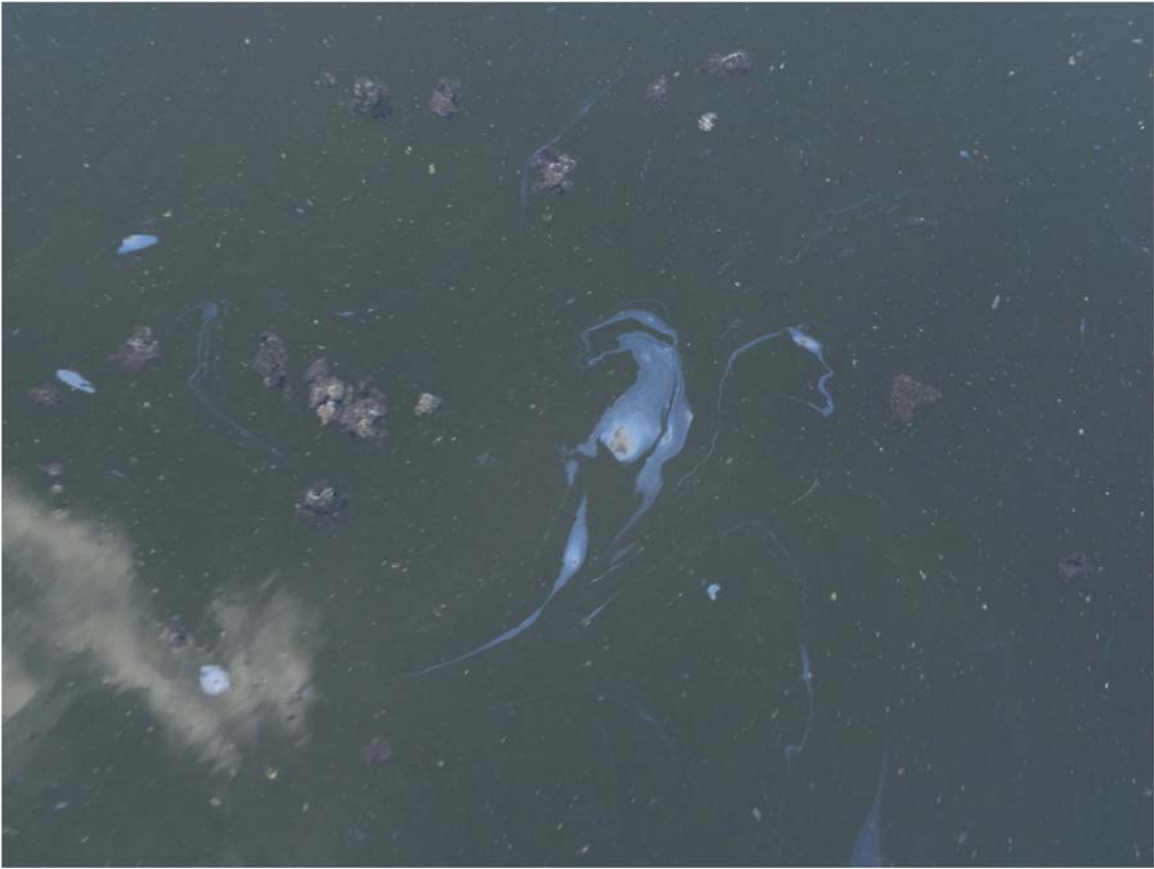
23. Morrow Lake north cove observed sheen.
